## Cameras and ESP32 placements

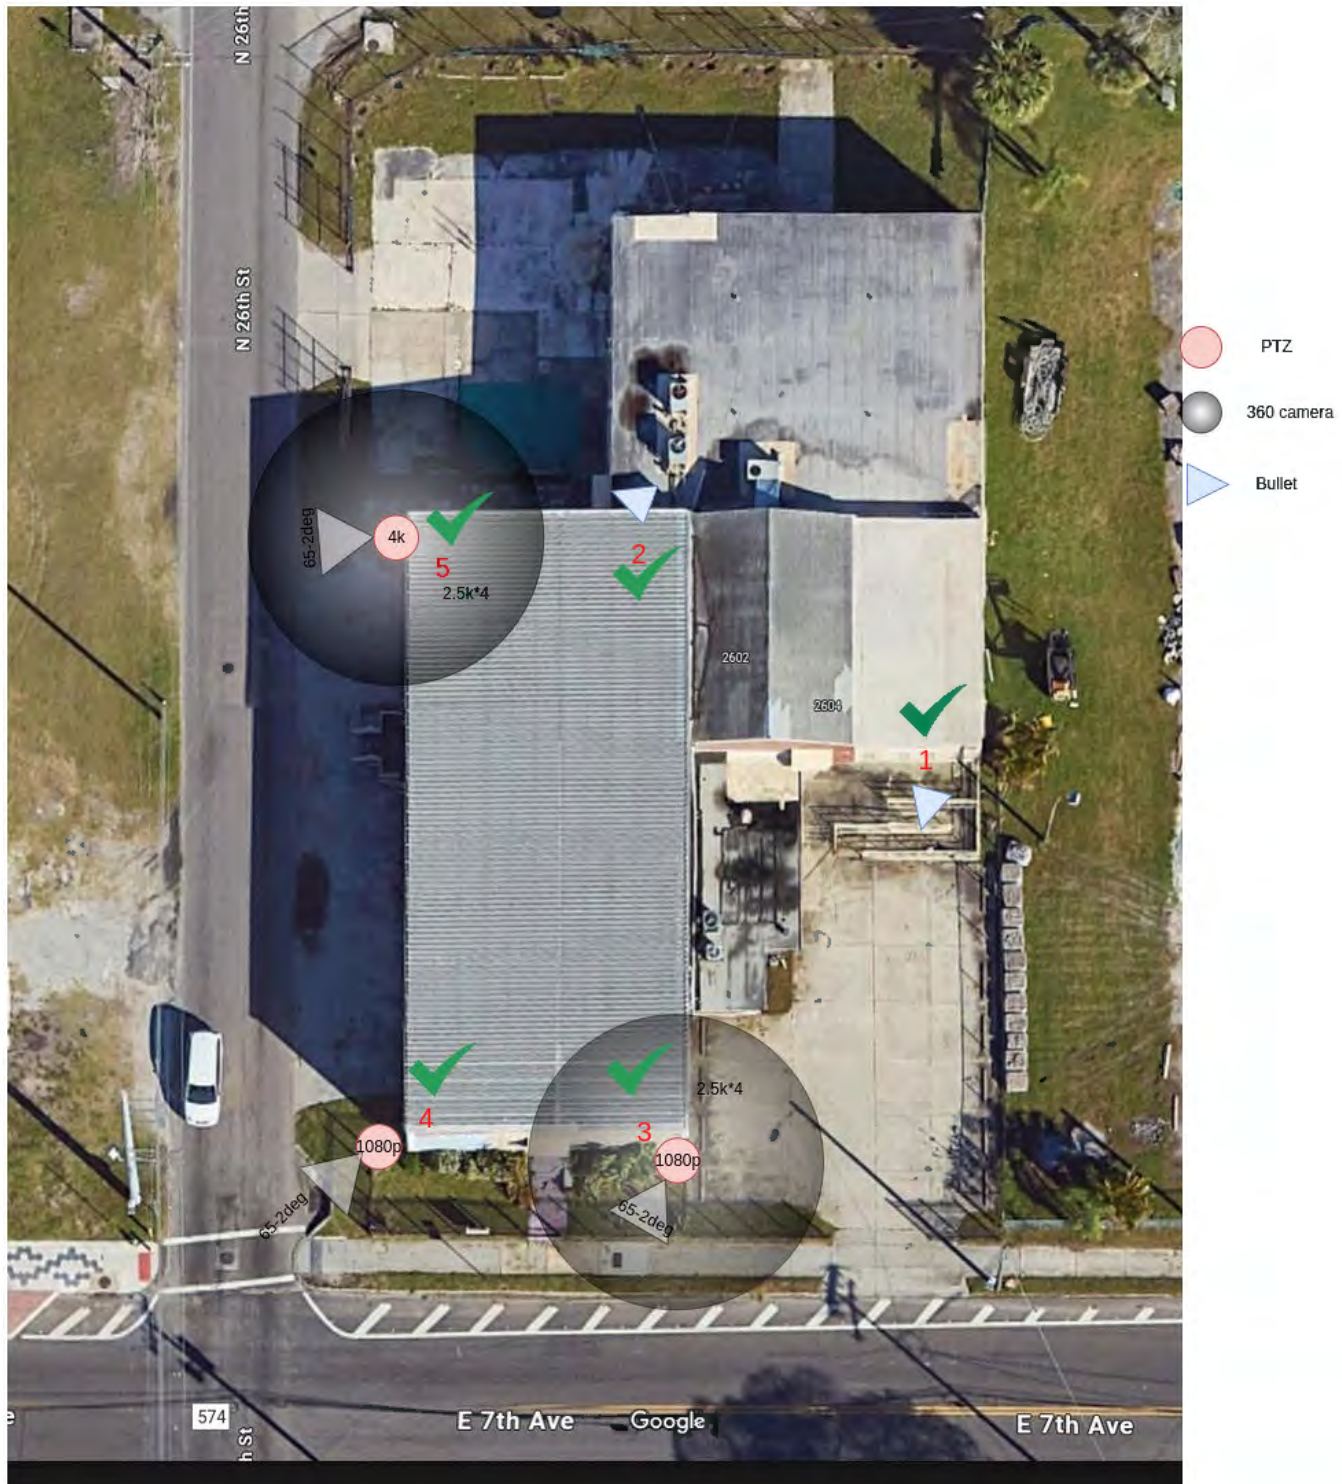
| Type | MAC Address | MSC Ybor Address | Link | Current Location<br>(Locations subject to change) | ESP32 MAC | Picture Identifier | |

| AXIS P1377<br>Bullet Medium | B8A44F72A<br>02D | 192.168.3.3 | rtmp://dev.imagery.jatf-dev.org<br>/AxisP1377_B8A44F72A02D | BackDoor of Ybor MSC<br><br>"lat": 27.960680751058,<br>"lon": -82.43045230955421,<br>"alt": 6 | GS_5A:<br>CF:EA | 2 | |
| AXIS Q6010 4-<br>barrel Dome | B8A44FBD<br>C5A0 | 192.168.3.4 | rtmp://dev.imagery.jatf-dev.org<br>/AxisQ6010_B8A44FBDC5A0CAM1<br><br>rtmp://dev.imagery.jatf-dev.org<br>/AxisQ6010_B8A44FBDC5A0CAM2<br><br>rtmp://dev.imagery.jatf-dev.org<br>/AxisQ6010_B8A44FBDC5A0CAM3<br><br>rtmp://dev.imagery.jatf-dev.org<br>/AxisQ6010_B8A44FBDC5A0CAM4 | NW Corner of Ybor MSC<br><br>"lat": 27.960674828274005,<br>"lon": -82.43056362122974,<br>"alt": 10 | GS_8C:89:<br>FA | 5 | |
| AXIS Q6075<br>1080p PTZ | B8A44FF9E<br>231 | 192.168.3.6 | rtmp://dev.imagery.jatf-dev.org<br>/AxisQ6075_B8A44FF9E231 | SW Corner of Ybor MSC<br><br>"lat": 27.960375729094906,<br>"lon": -82.43056495576955,<br>"alt": 10 | GS_8C:8A:<br>CE | 4 | |
| AXIS Q6010 4-<br>barrel Dome | B8A44FBD<br>DAB1 | 192.168.3.7 | rtmp://dev.imagery.jatf-dev.org<br>/AxisQ6010_B8A44FBDDAB1CAM1<br><br>rtmp://dev.imagery.jatf-dev.org<br>/AxisQ6010_B8A44FBDDAB1CAM2<br><br>rtmp://dev.imagery.jatf-dev.org<br>/AxisQ6010_B8A44FBDDAB1CAM3<br><br>rtmp://dev.imagery.jatf-dev.org<br>/AxisQ6010_B8A44FBDDAB1CAM4 | SE Corner of Ybor MSC<br><br>"lat": 27.96037717905989,<br>"lon": -82.43041146769046,<br>"alt": 10 | GS_31:<br>CD:2A | 3 | |
| AXIS P1377<br>Bullet Medium | B8A44F8F2<br>389 | 192.168.3.9 | rtmp://dev.imagery.jatf-dev.org<br>/AxisP1377_B8A44F8F2389 | Front Entrance of Ybor MSC<br><br>"lat": 27.960559333921285,<br>"lon": -82.43025382608461,<br>"alt": 10 | GS_31:1D:<br>32 | 1 | |
